Galvanic Sensor for Monitoring Structural Damage

ABSTRACT

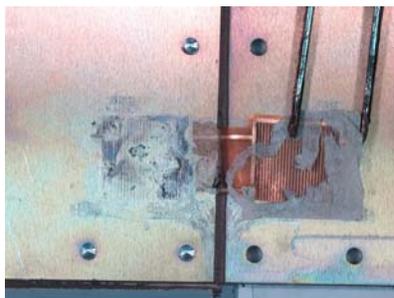
Figure 11: CCC pretreated coupon sandwich test coupon: inside view.

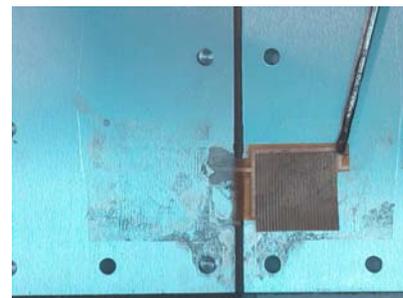
Figure 12: Cr(III) pretreated sandwich test coupon: inside view.
