The Flight of Phoenix

LtCol Bengt Persson/Mr Hilbert Gustafsson

FMV

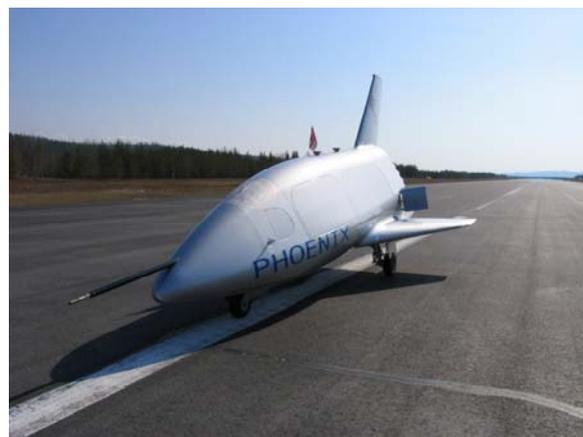
Picture 1. The Phoenix flight test vehicle

The main dimensions of Phoenix are:

Span 3.84m, length 6.9m, height 2.56m and a maximum weight of 1200 kg.

Two versions of Phoenix were used during flight test. For verification of helicopter handling qualities and under slung load flight characteristics, a wooden mock-up of the Phoenix was used. This was an existing

Both versions of the test vehicle were equipped with standard T-lugs to fit the ERU. The wooden mock up had the correct aerodynamic configuration and did not carry any instrumentation. It was ballasted to actual weight and centre of gravity.

The Phoenix test vehicle, intended for free flight, was complete with all necessary systems and test instrumentation.

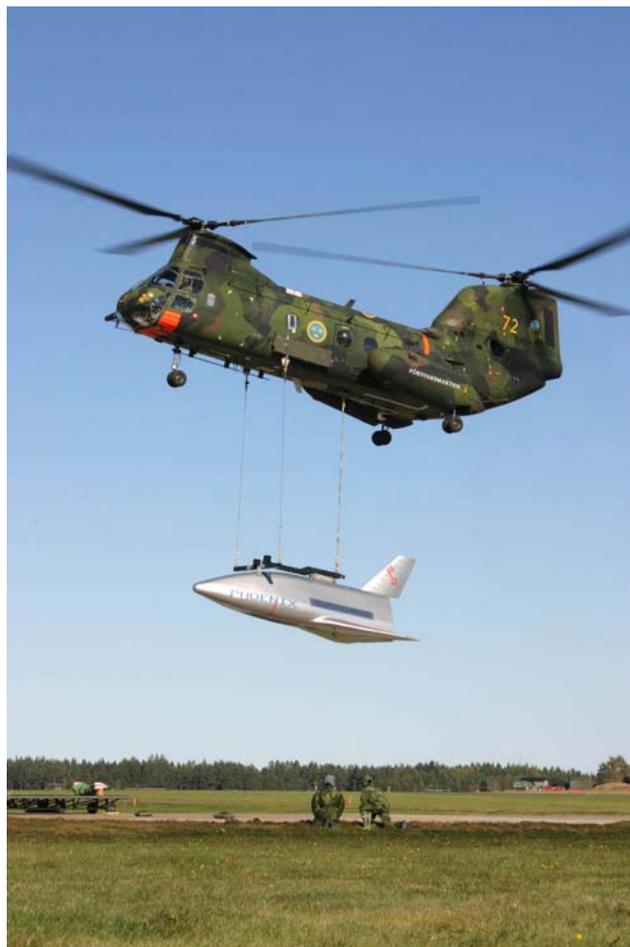
Picture 2. Hkp4 and the Phoenix wooden mock up

The T-bar was slung from the helicopter by three 5 m long steel wires with the aft wire attached to the standard central hook on the helicopter centreline and two forward wires attached to hooks, mounted, one on each side of the aircraft hull, at the standard weapon pylon attachments. The helicopter jettison system was modified so the external load could be jettisoned together with its steel wires. This meant that three load carrying hooks had to open simultaneously at initiation.

Before we could make handling quality flights with the wooden mock up, we used a ballasted drop tank from a VIGGEN fighter to simulate weight and centre of gravity of the Phoenix. It is worth mentioning that the centre of gravity is situated just some centimetres ahead of the aft steel wire.

Flight tests with the wooden mock up showed that the estimations were correct. Flight characteristics and helicopter handling qualities could be verified in the complete permissible flight envelope.

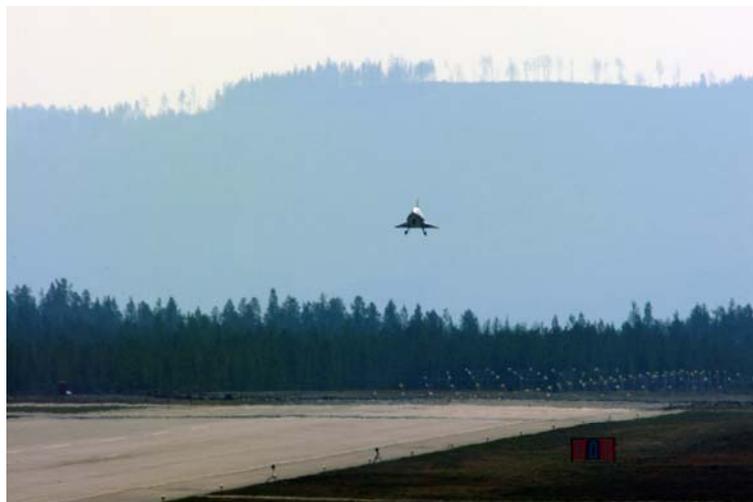
Picture 3. First landing of the Phoenix flight test vehicle

The Phoenix flared, reduced speed, adjusted attitude and made a very smooth touch down, lowered its nose and wheel braked, coming to rest with the nose wheel on the runway centre line.
